## Service telegram

DISTRIBUTOR- Motor vehicle: FZD, NKW  
TYPE FUEL- Workshop: EP  
INJECTION PUMP 07.1997  
ST 0532 En

DAMAGE CAUSED BY DIESEL FUELS  
WITH LOW SULPHUR CONTENT

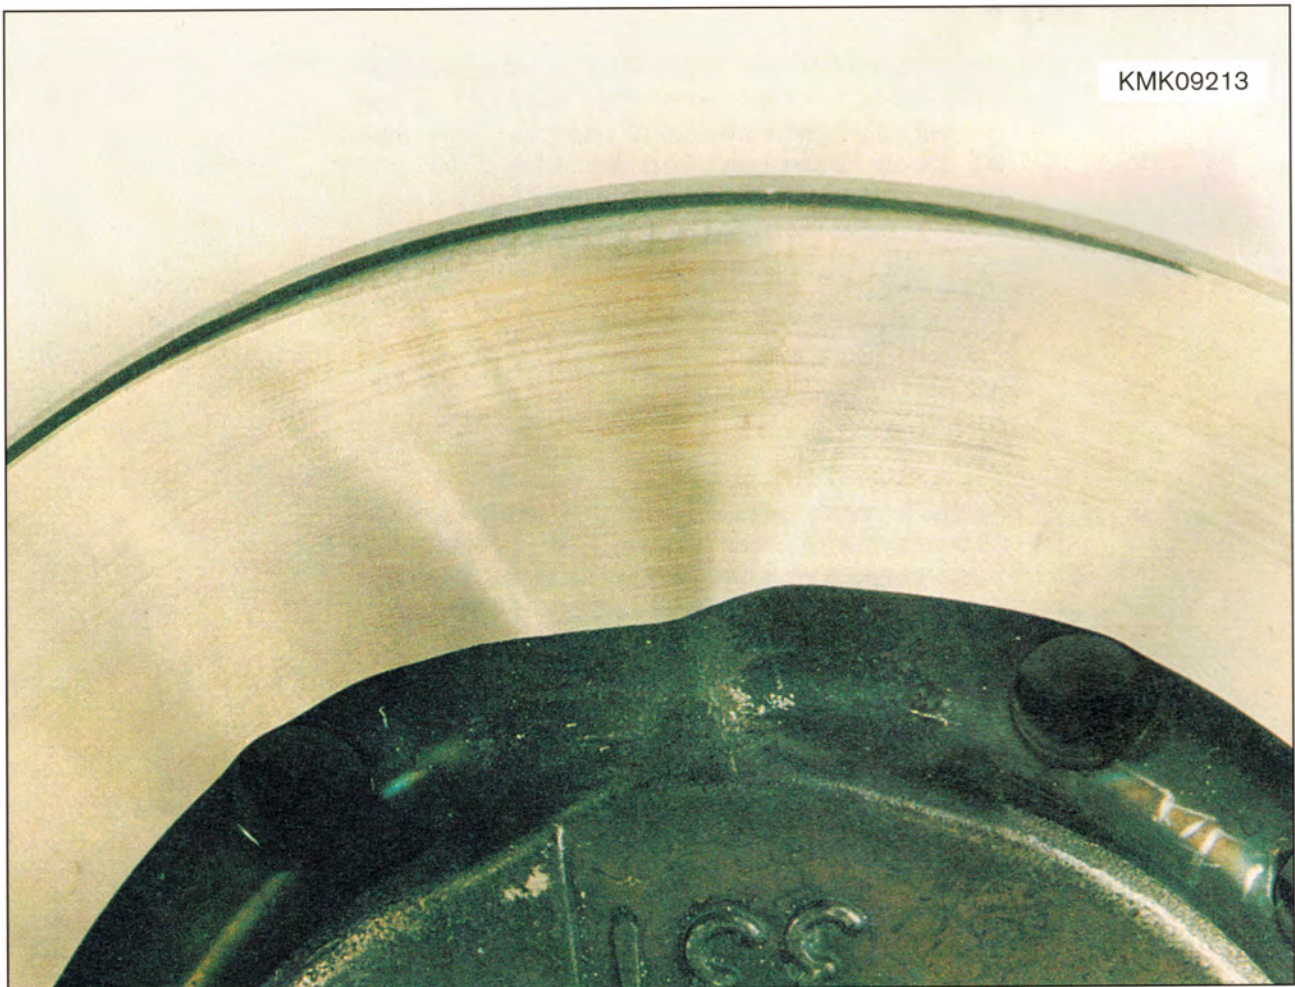
\* Cam track, control lever:

Little abrasion in the case of fuel  
w i t h additive

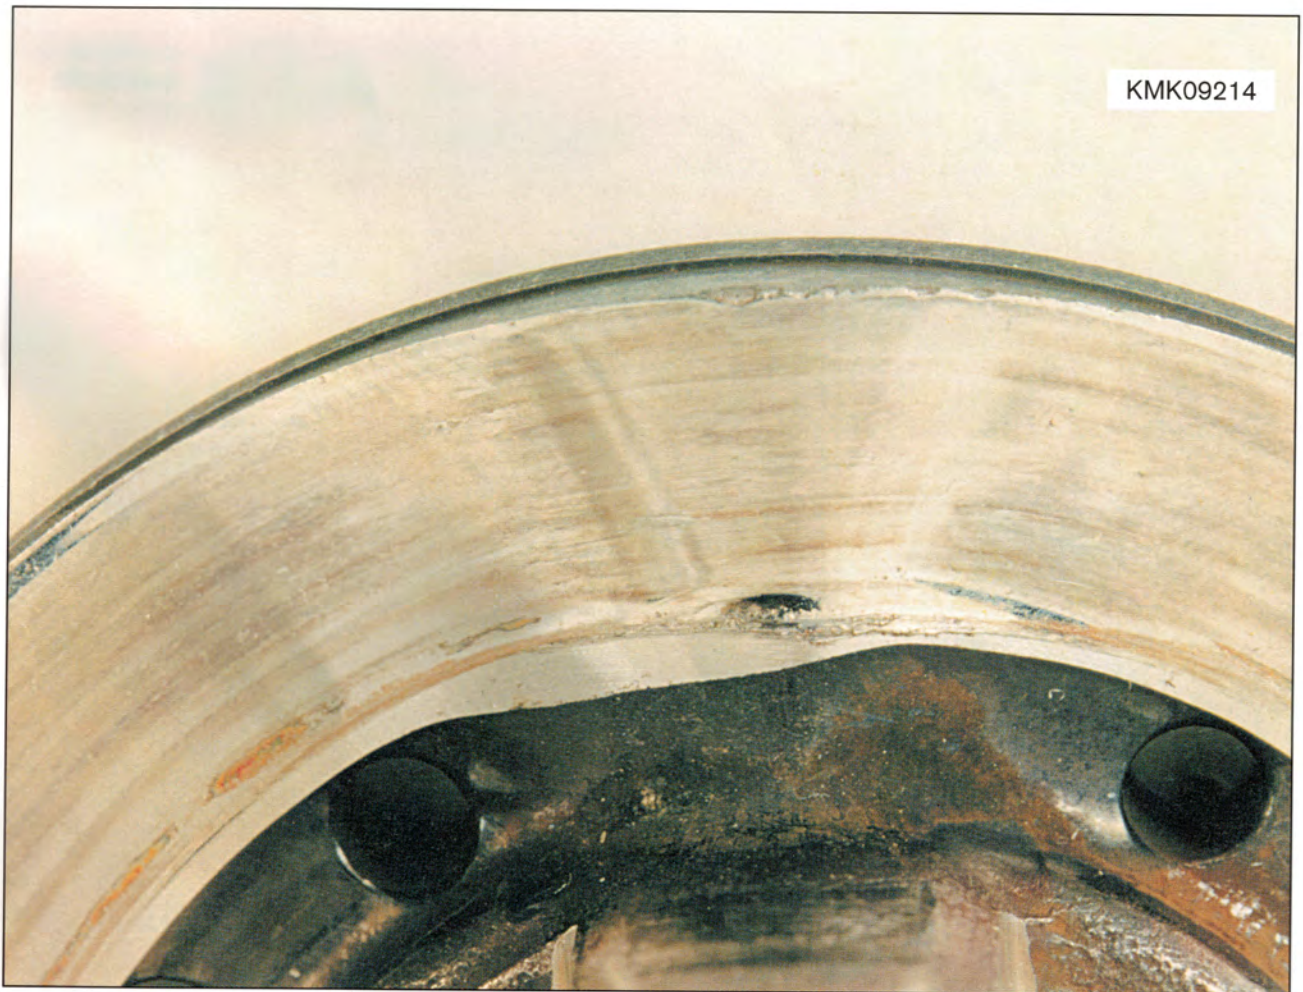
\* Cam track, control lever

The reduced lubricity can result in increased distributor-type fuel-injection pump wear if exclusive use is made of diesel fuel without lubricating additives.

Severe abrasion in the case of fuel  
w i t h o u t additive

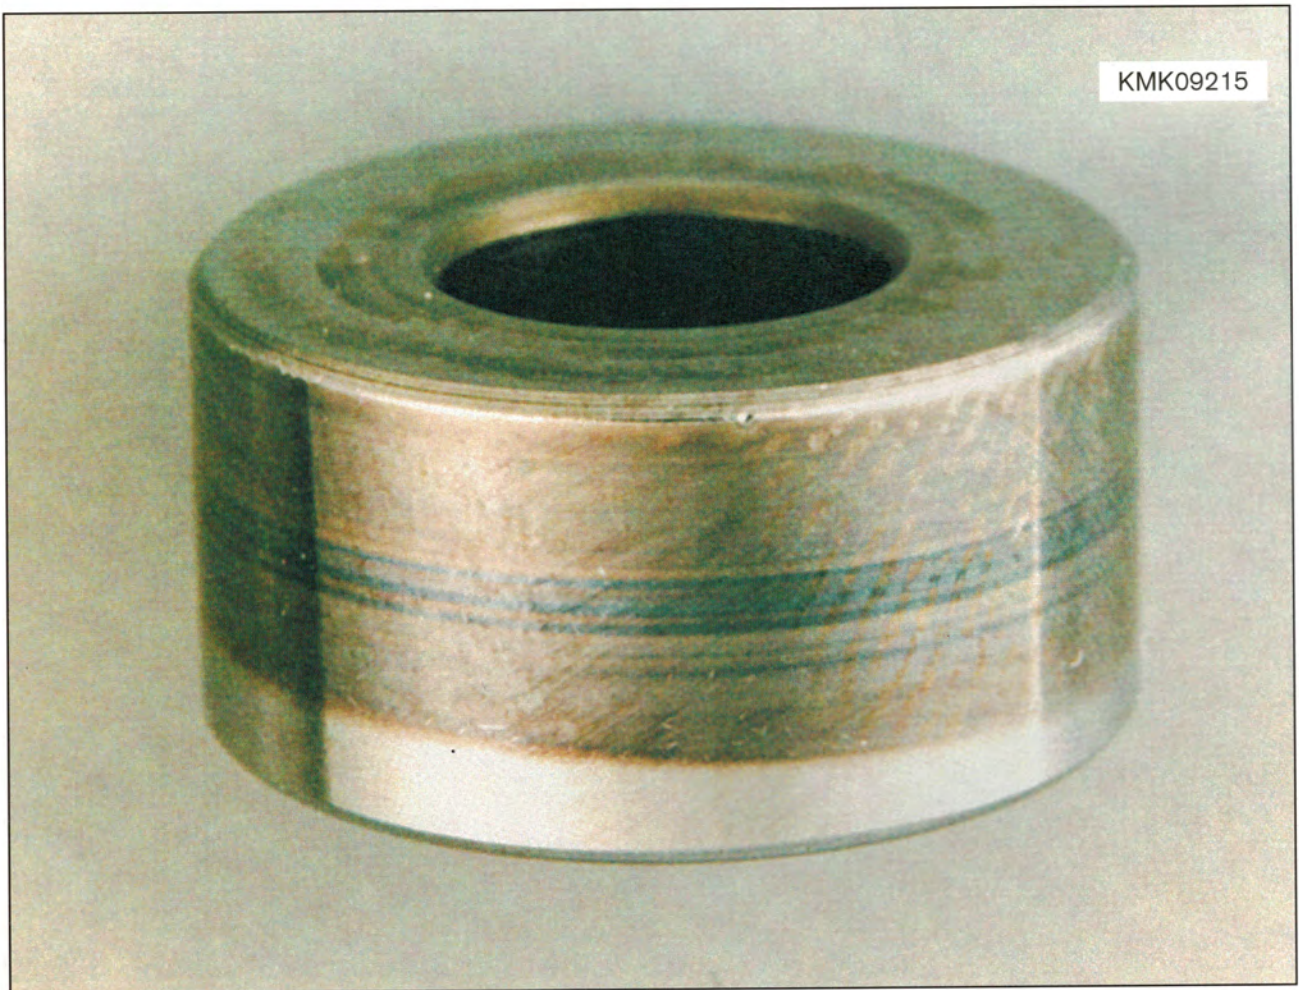
\* Roller (cam roller ring)

Little abrasion in the case of fuel  
w i t h additive

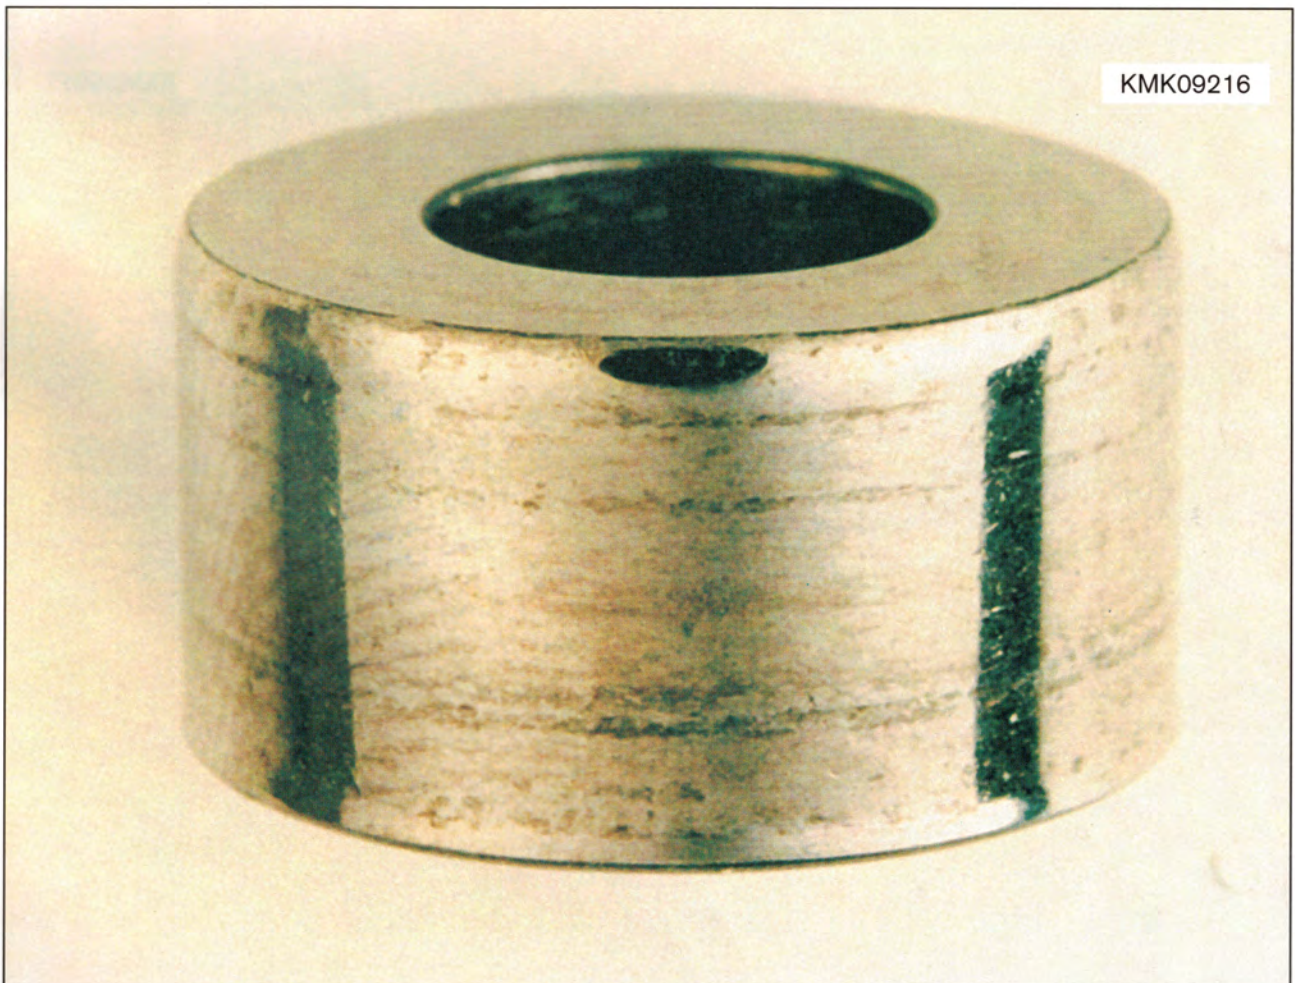
\* Roller (cam roller ring)

Severe abrasion in the case of fuel  
w i t h o u t   a d d i t i v e

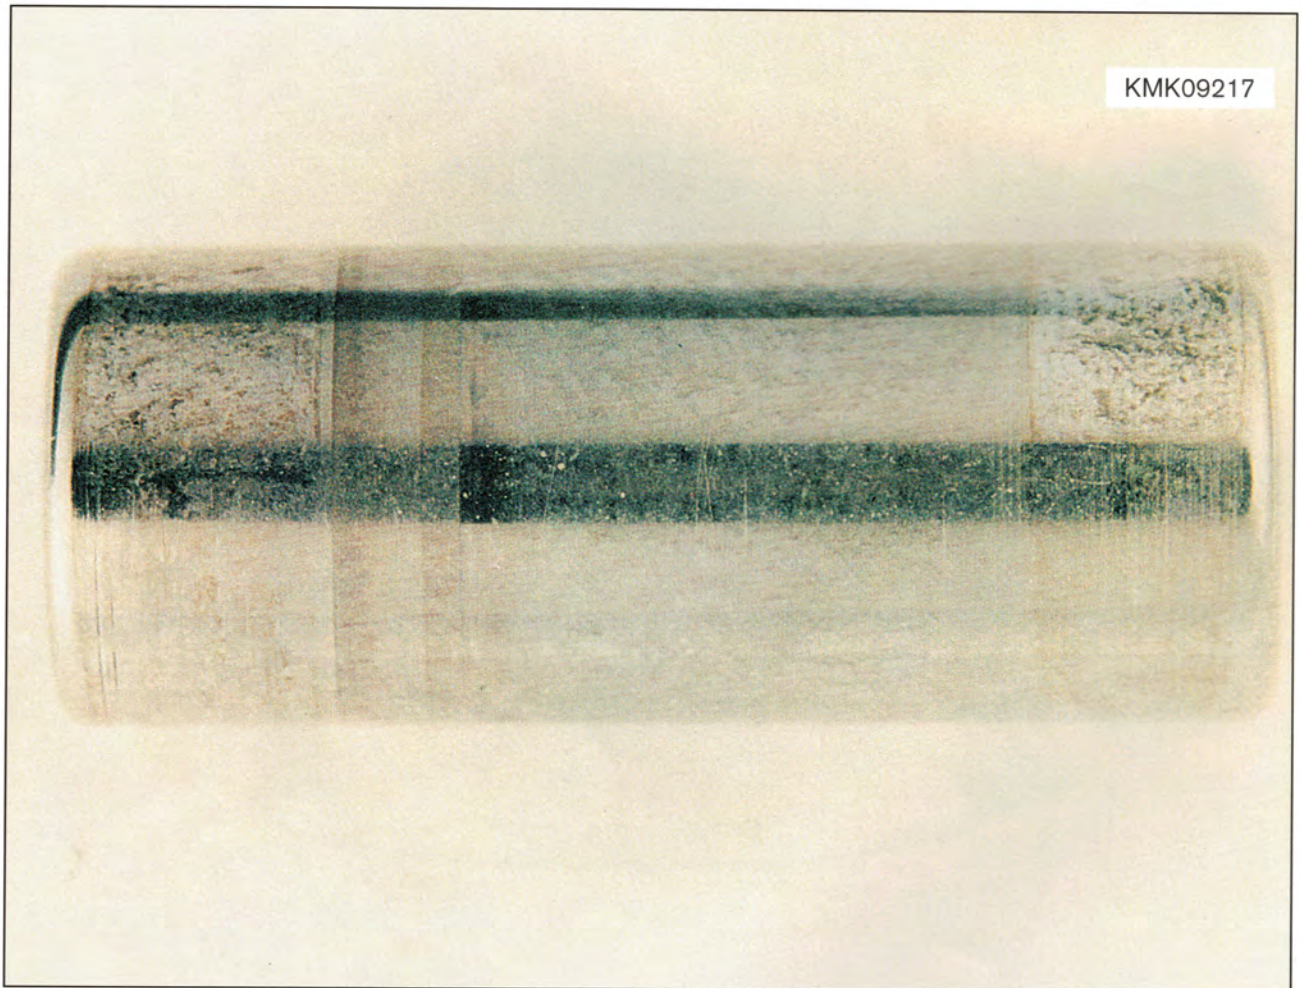
\* Roller pin

Little abrasion in the case of fuel  
w i t h additive

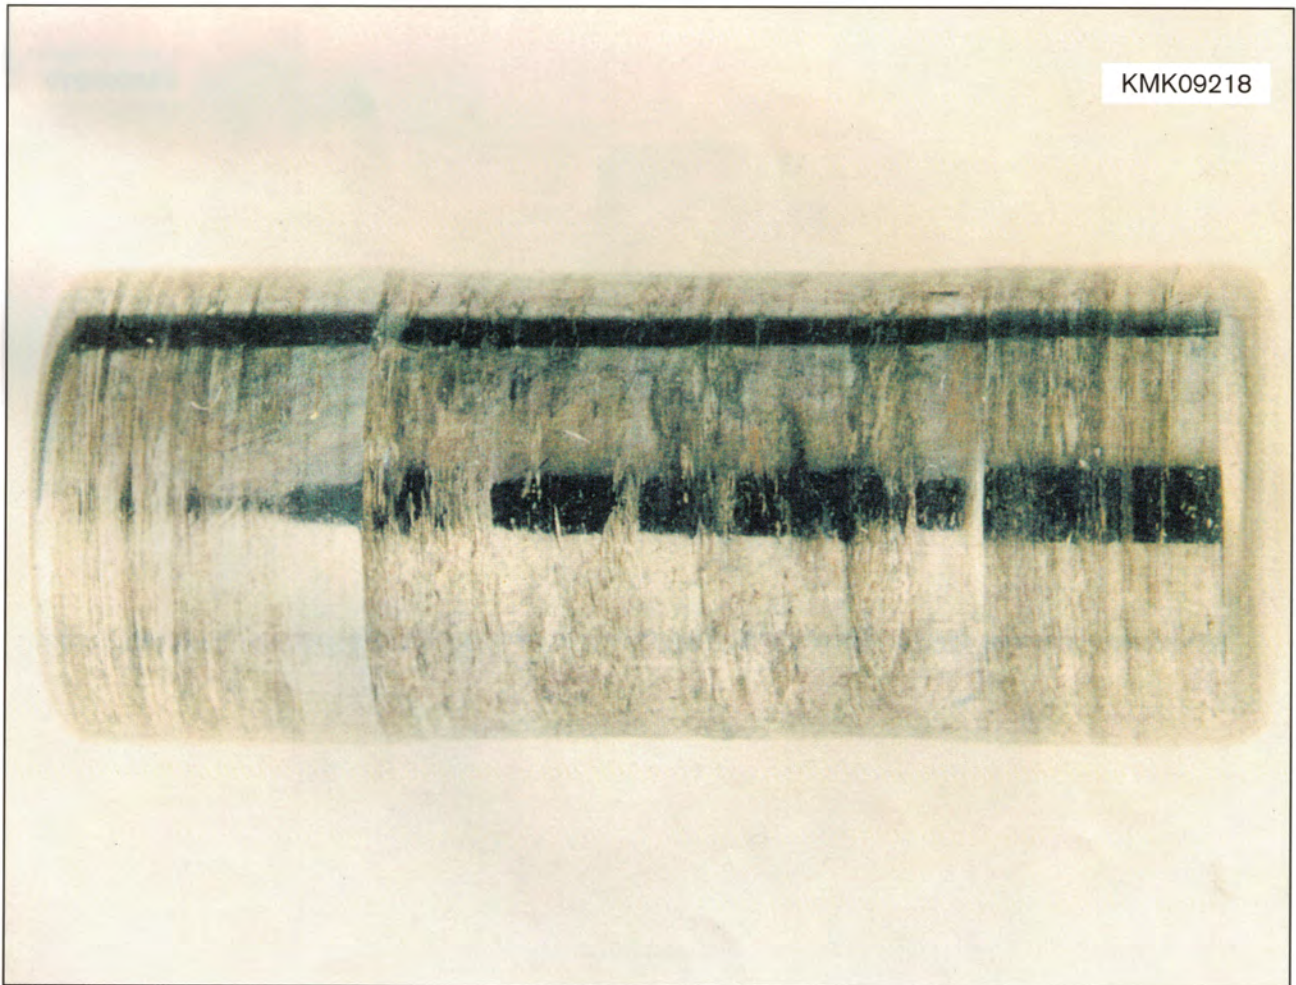
\* Roller Pin

Severe abrasion in the case of fuel  
w i t h o u t additive

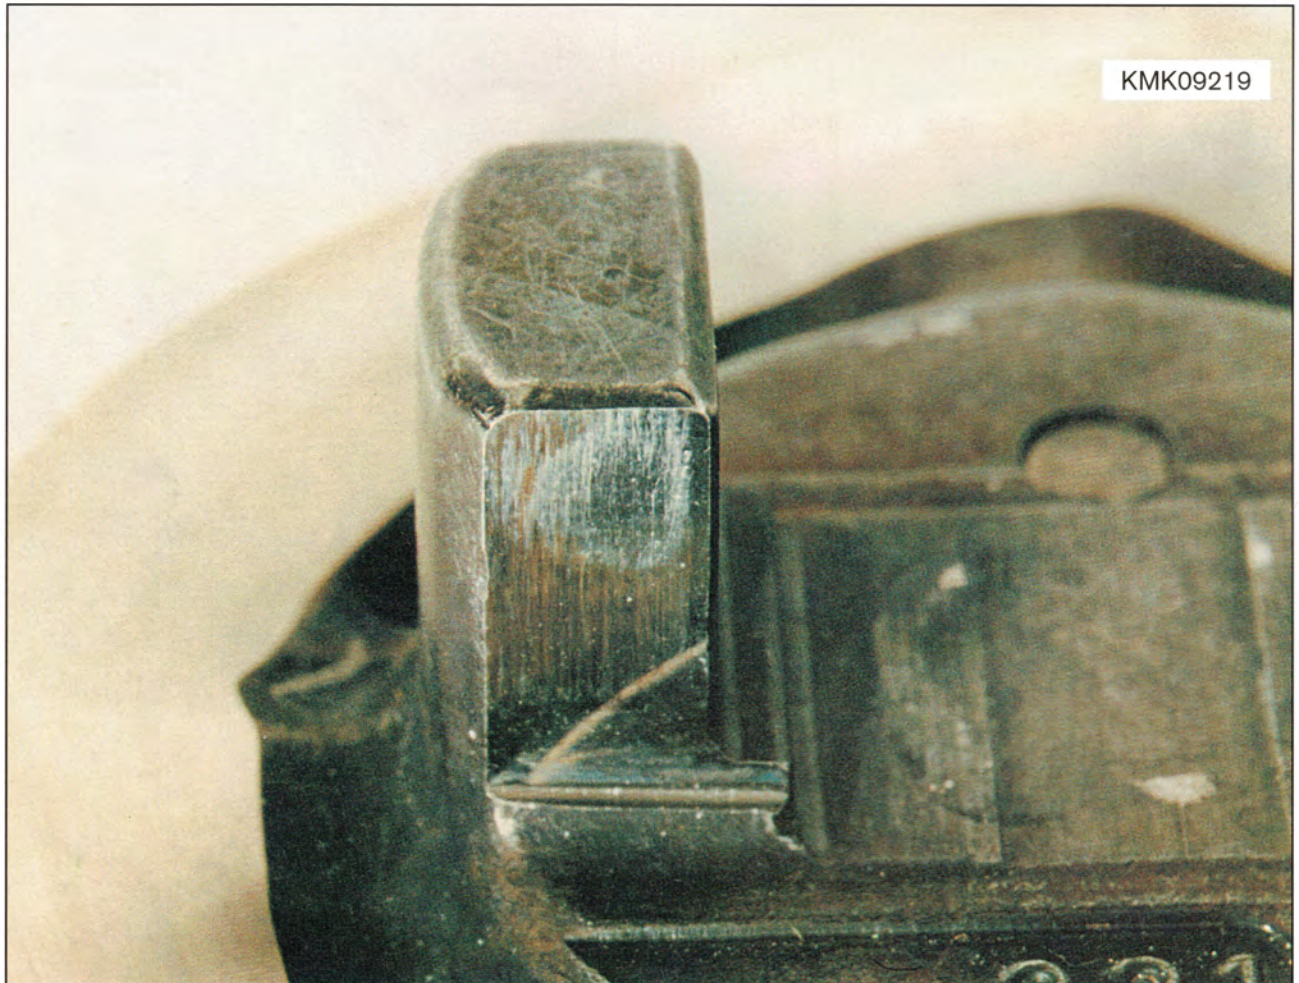
\* Control lever claw

Little abrasion in the case of fuel  
w i t h additive

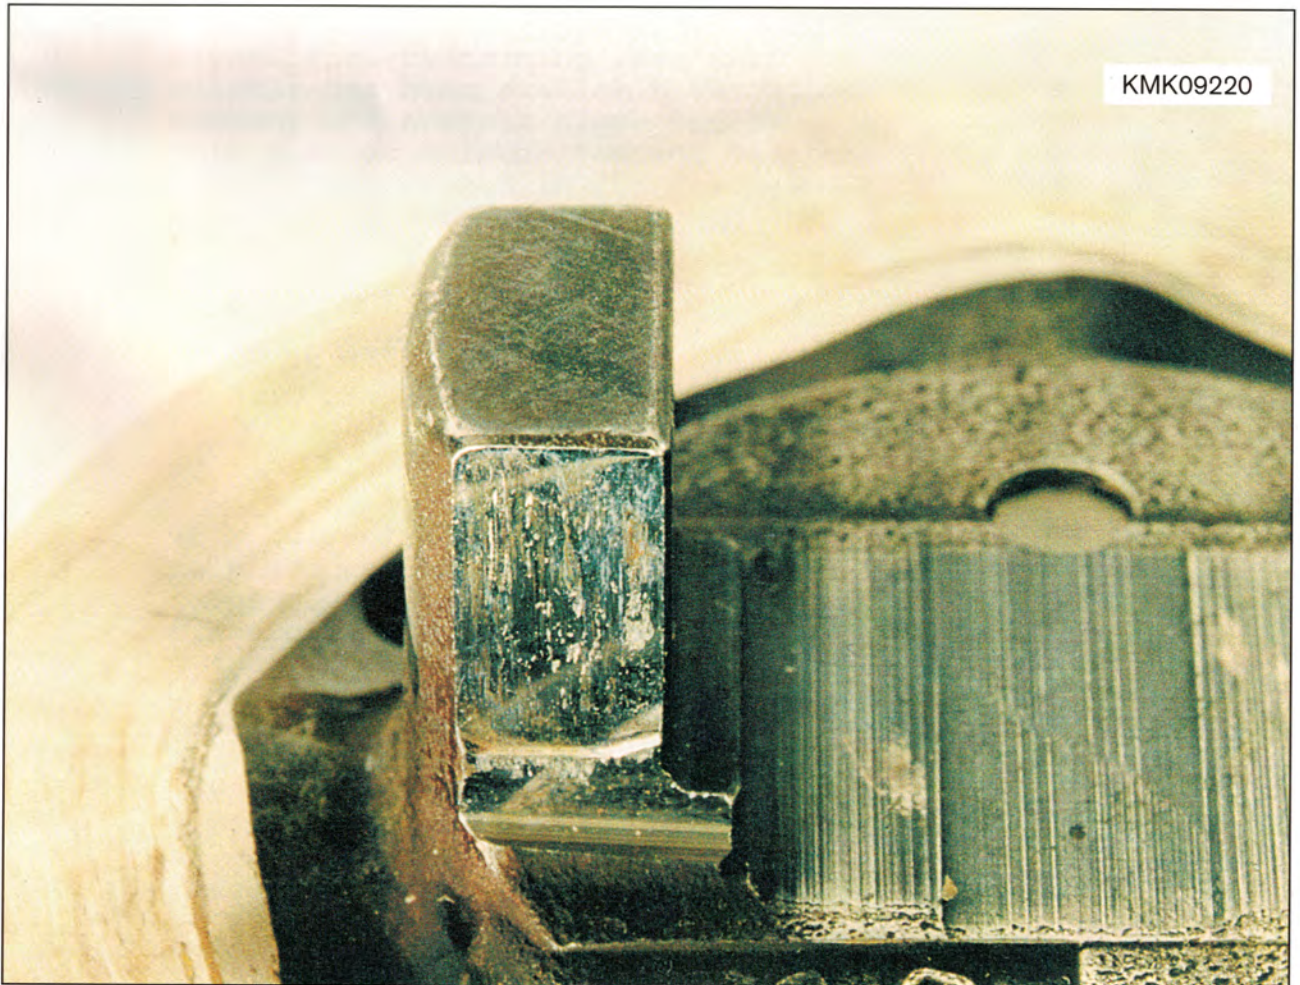
\* Control lever claw

Severe abrasion in the case of fuel  
w i t h o u t   a d d i t i v e
